# 'Dot and dab'

'Dot and dab' is a technique that was developed to replace traditional wet plastering and it is now frequently used in new buildings. It became prevalent in England during the late seventies and quickly gained in popularity due to its lower costs, faster installation, quicker drying time and ease of finishing. Walls finished in this way can be painted almost immediately. Dry lining, as the process is known, is widely used by builders and developers and is particularly useful because it can be used on both wooden and masonry internal partitions and ceilings, as well as the outside walls. Despite its benefits 'dot and dab' is not without problems, and we will have to live with the consequences of these for generations to come. Tony Cowling discusses the shortcomings of the method ...

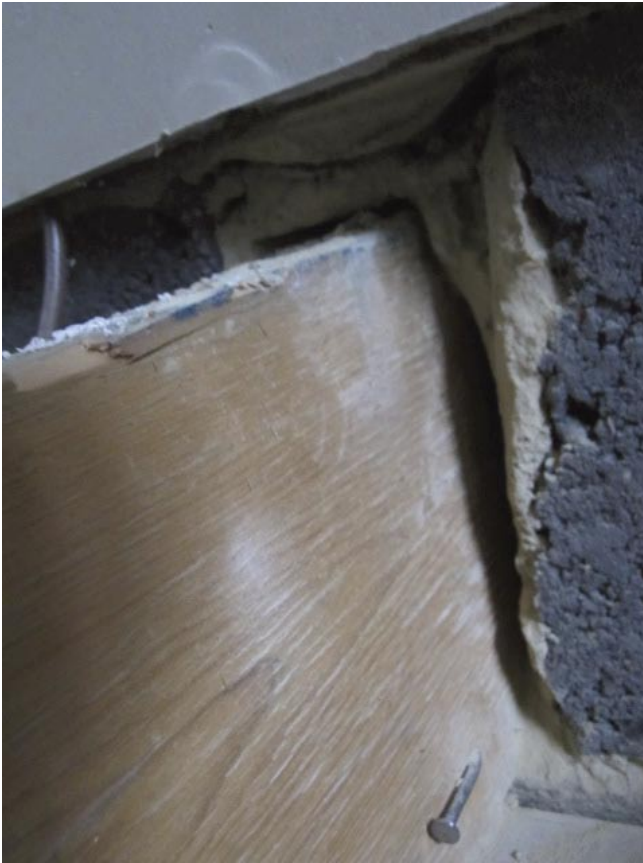
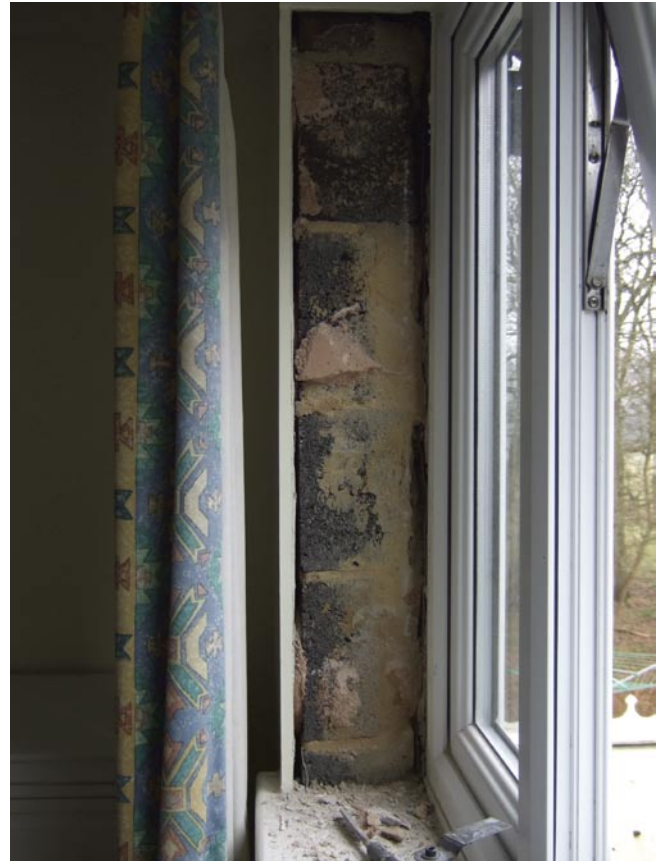
*Building works are rarely properly sealed off behind dot and dab dry walling as the pictures here indicate.*

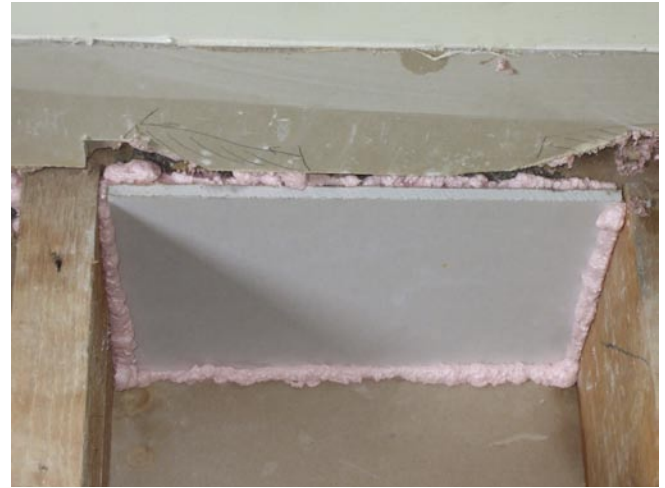
Fully 'buttering' a suitable sized piece of board with bonding plaster or even with fixing foam and sticking it to the wall can be suitable for sealing gaps in the floor void walls.

It is a good opportunity to seal this and foam can be used this time. Once good access is available we strongly recommend sealing all the outside wall masonry between the ceiling and the floor. Several approaches to this are possible: plastering it, fully buttering a suitably sized piece of board with bonding plaster or even with fixing foam and sticking it to the wall (see picture right) and sealing round it with foam. The sealing should continue up behind the first floor plasterboard lining to ensure that no draughts can get either into or out of the void behind the linings.

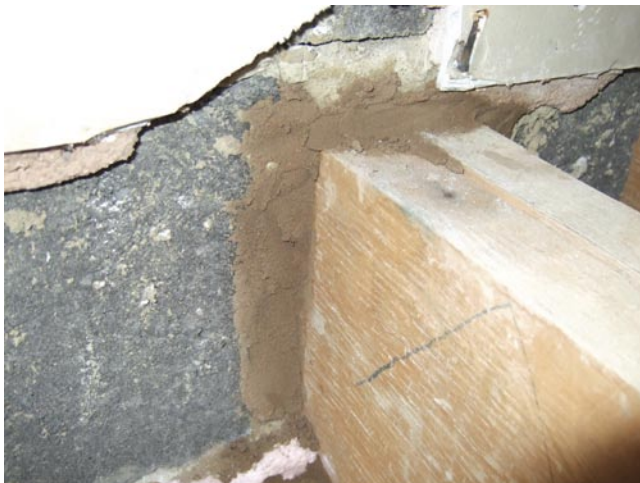
Where internal walls abut outside walls it is very likely that air can get from behind the plasterboard on the outside wall to behind the plasterboard on any masonry internal wall. From there it will have a general cooling effect and will try to escape into the building under the skirting, through sockets and switches and even from behind or over architraves, door linings even around pipes. The best place

to seal these is at the point of abutment, but this is by no means easy so it may be as well to seal all the possible exit routes. One good thing is that generally the floor boarding upstairs and the ceilings are fixed before the partitions are built, but if the walls are load bearing then there could be a gap leading into the loft, sadly on the ground floor. If they are solid walls, there will often be gaps at the edge of the ceilings allowing air to get from outside walls via internal walls and into the floor void and the places mentioned above.

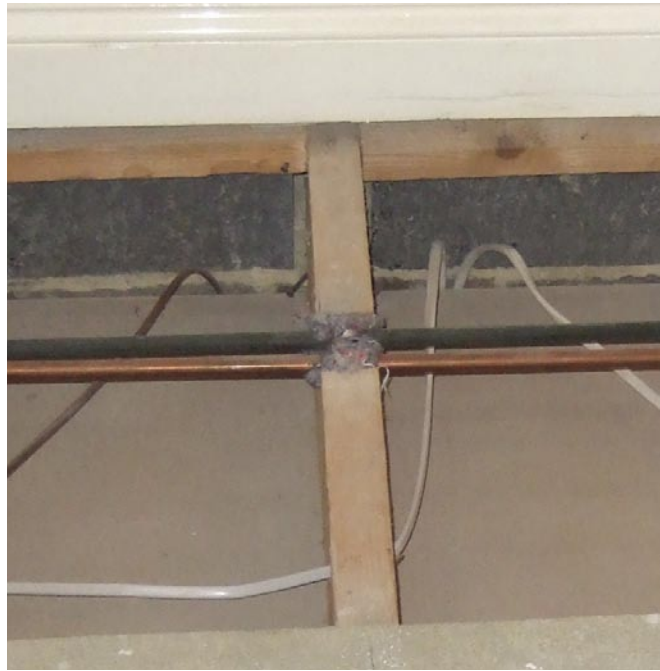
*Cable runs and entries can allow draughts to enter and circulate. These can be safely sealed with acrylic sealant. In new homes or on rewiring this should be done routinely.*

These problems are not isolated to the types of homes we are discussing but are problems in all buildings. Mains gas, water, drains, electricity and communications' wires are often in sleeves or ducts and these can bring in draughts both round the duct as well as between the services and the duct. Cable entries to ceiling fittings can allow draughts to enter and these can be safely sealed with acrylic sealant. In new homes, or on rewiring, this should be done routinely now. Waste pipes, where they pass through walls or floors, can be draughty too and pipe casings, especially soil pipe boxes may require special attention at both floor and ceiling levels.
